**File Number** G20H006  
**Type of Operation** CAMPS - < 50 Man Camp  
**Location** James Creek Highway Maintenance Camp

## ENVIRONMENTAL INSPECTION REPORT

<b>Permittee:</b>	GNWT Department of Infrastructure	<b>Permit Expiry Date:</b>	August 05, 2023
<b>Land Use Permit No.</b>	G20H006	<b>Previous Inspection:</b>	February 21, 2023
<b>Quarrying Permit No.</b>		<b>Inspection Date:</b>	May 30, 2023
<b>Contractor:</b>		<b>Subcontractor:</b>	
<b>Location(s) Inspected:</b>	James Creek Highway Maintenance Camp		
<b>Current Stage of Operation:</b>	Active		
<b>Program Modifications Approved:</b>

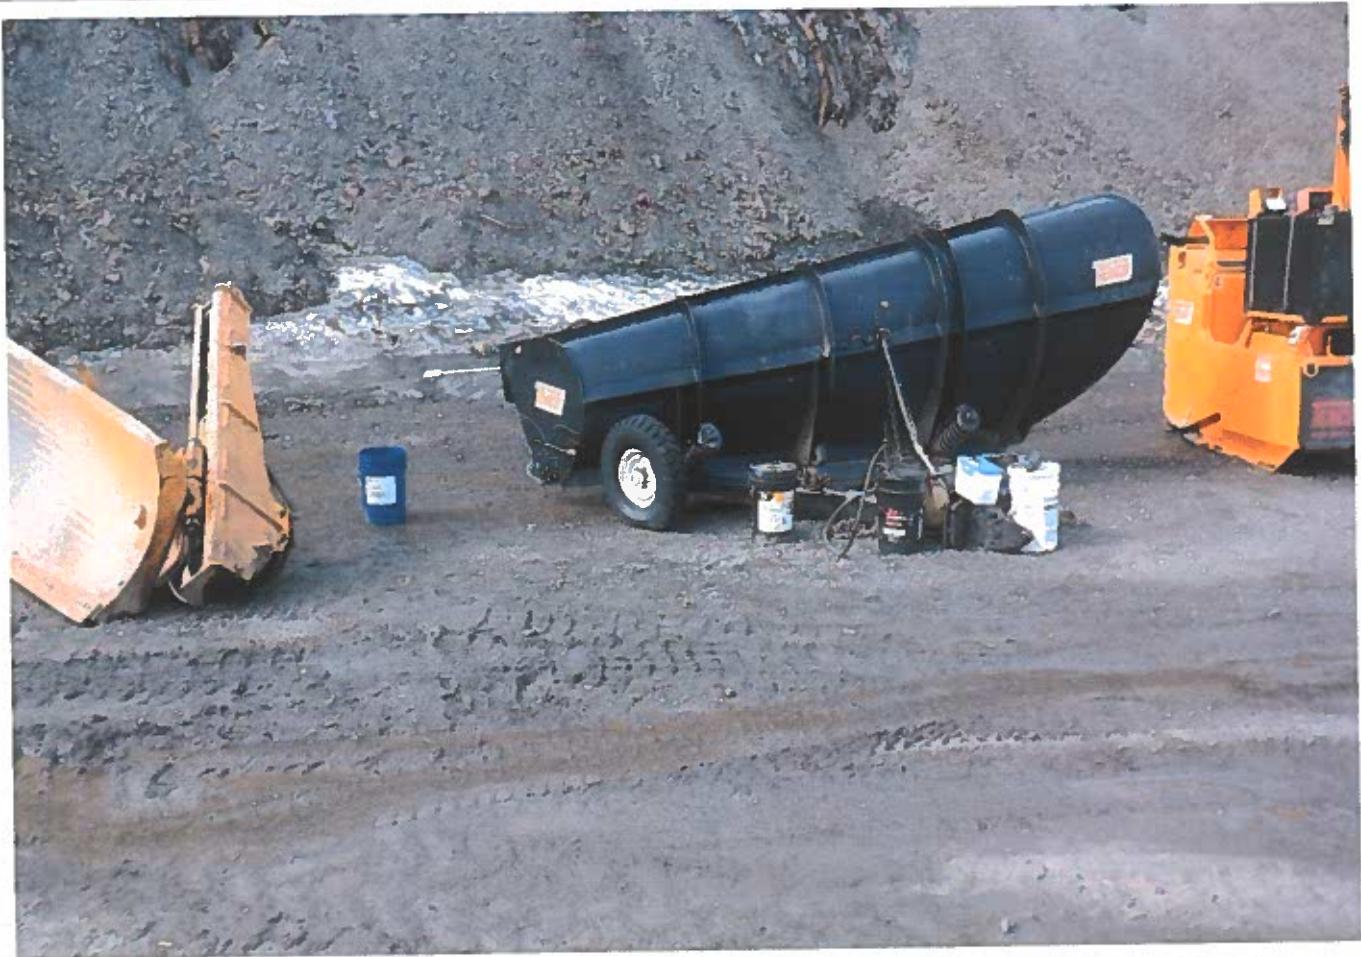
**Figure 1**

During the inspection there was one concern observed by the inspector. Behind the shop there were four (4) pails of hydrocarbon with no secondary containment and one of them were not sealed/covered. The Department of Environment and Climate Change Land and Water division would like to recommend that the Waste Management Plan be reviewed by all applicable parties to eliminate any potential spills. All other aspects of the operation were satisfactory.

**The four pails of hydrocarbon behind the shop.**

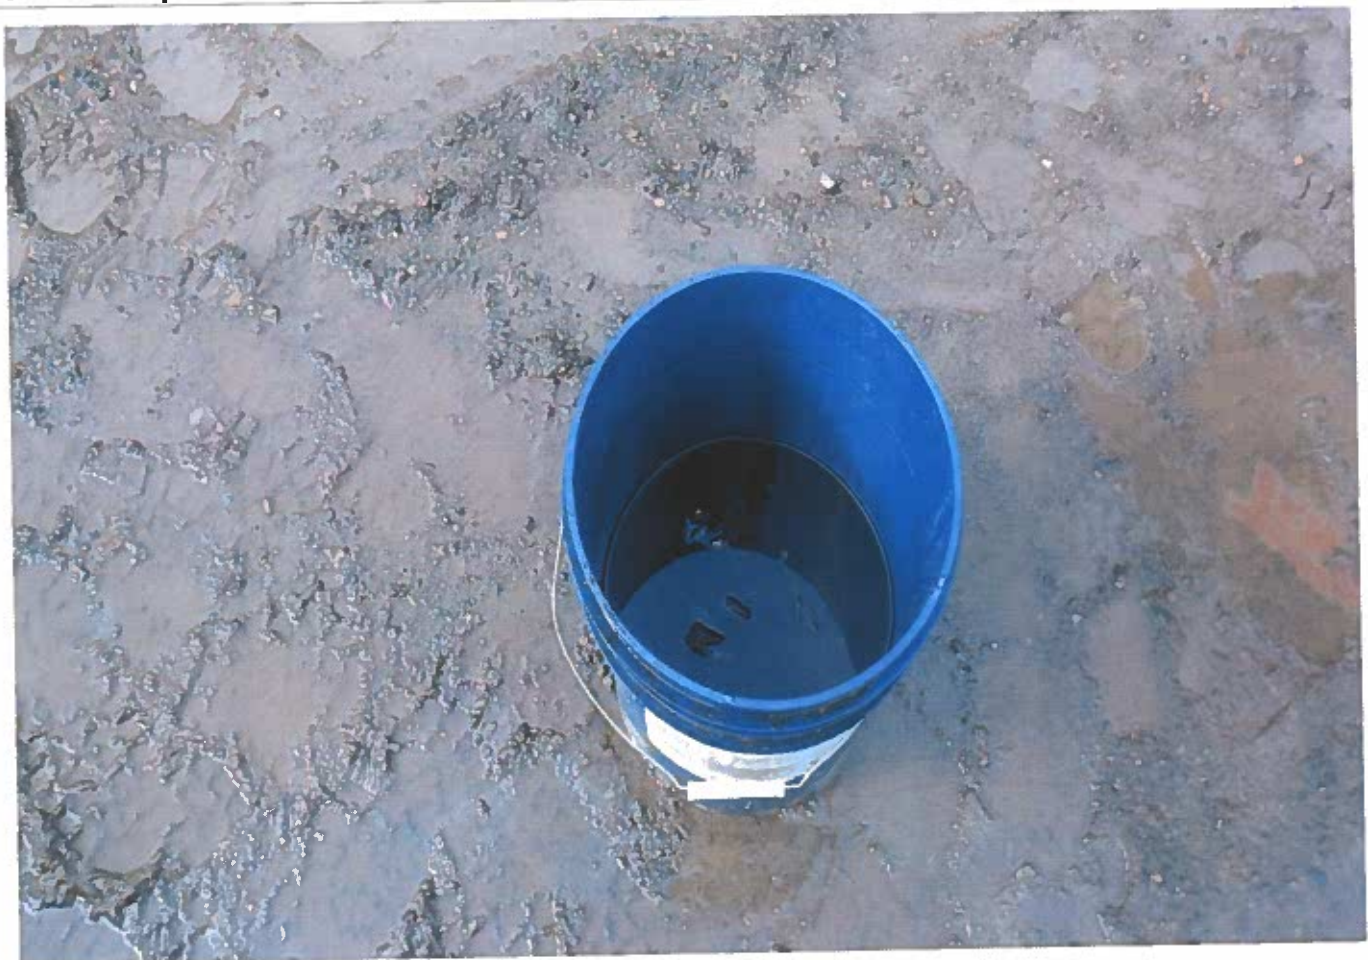
**Figure 2**

**One of the pails that were not covered.**
