## OPERATION SUMMARY INSPECTION REPORT

Well/Facility Name:	Cameron A-03 Cameron J-62 Cameron I-73 H-03 Battery	Operator:	Receiver on behalf of Strategic Oil and Gas Ltd.
Location of Inspection:	Cameron Hills	Access method:	1km South of Indian Cabins, Alberta on the West side of Highway 35
Site Contractor:	Energy Works Management	Status:	Non-Compliant Suspended Wells
Approval Info	ACW-2019-005-SOG-A-03-WID2047 ACW-2019-004-SOG-J-62-WID1158 ACW-2019-003-SOG-I-73-WID1937 OA-2018-003-SOG	WID:	2047 1158 1937
Date of Inspection	March 10, 2020	H2S Site:	Yes

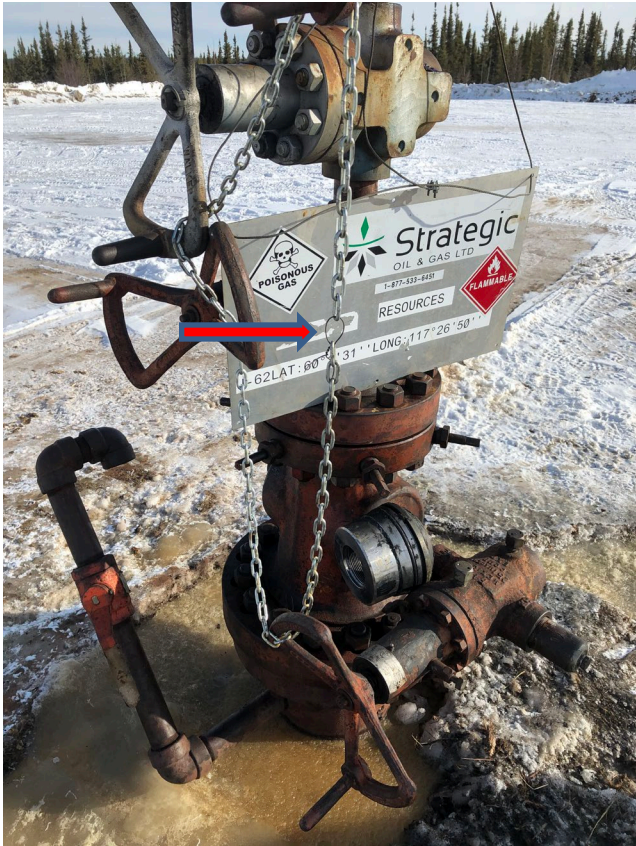
Hazard identification and signage	Y <sup>2</sup>	All "Out of Service" signs were in place on empty storage tanks at well sites except the methanol tank at I-73 (See Photo # 4). 2. Replacement "Out of Service" sign at the I-73 methanol tank was installed during the inspection,
ERP, Safety Plan available upon request	Y	These plans were available at the well site supervisor's trailer and matched the updated documents provided to OROGO for their 2020 operational season.
Other	N/A	
<b>Blowout Prevention Equipment</b>		
BOP Certifications	N/A	Service rig operations had concluded by the time of the inspections.
BOP Pressure rating	N/A	Service rig operations had concluded by the time of the inspections.
Kill sheet in dog house	N/A	Service rig operations had concluded by the time of the inspections.
Stabbing valves and cross overs	N/A	Service rig operations had concluded by the time of the inspections.
BOP crew drills	N/A	Service rig operations had concluded by the time of the inspections.

- Well head sign in place with proper emergency contact number;
- Surface casing vent open, valve appears to be operating and no sign of surface casing vent flow;
- Well head valves chained and locked;
- Methanol tank missing “Out of Service” sign – Corrected during inspection; and
- Wind sock frame in place but fabric needs replacement – Fabric sock on order.

**Photo # 4:** I-73 empty methanol tank missing "Out of Service" sign.

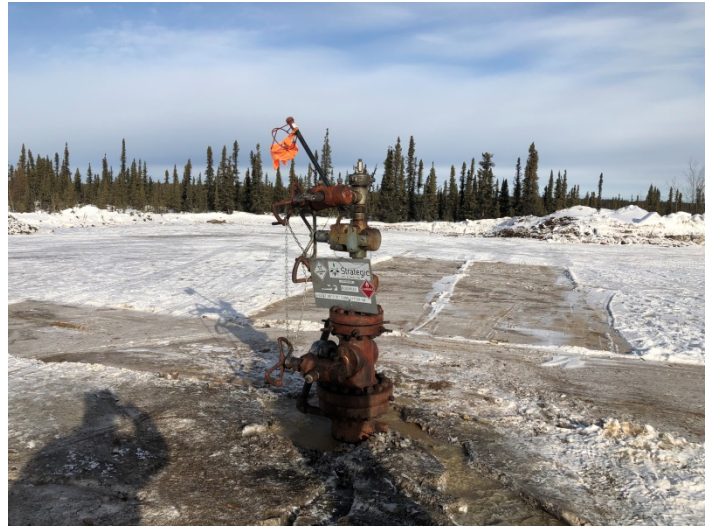
- Well head sign in place with proper emergency contact number;
- Surface casing vent open, valve appears to be operating and no sign of surface casing vent flow;
- Well head valves chained but not locked. Chain ends held together by wire (See Photo # 5)- Corrected during inspection;
- No infrastructure on site other than the well head;
- No debris on site; and
- Wind sock frame in place but fabric needs replacement – Fabric sock on order (See Photo # 6).

**Photo # 5:** J-62 Valve chain connected by wire.

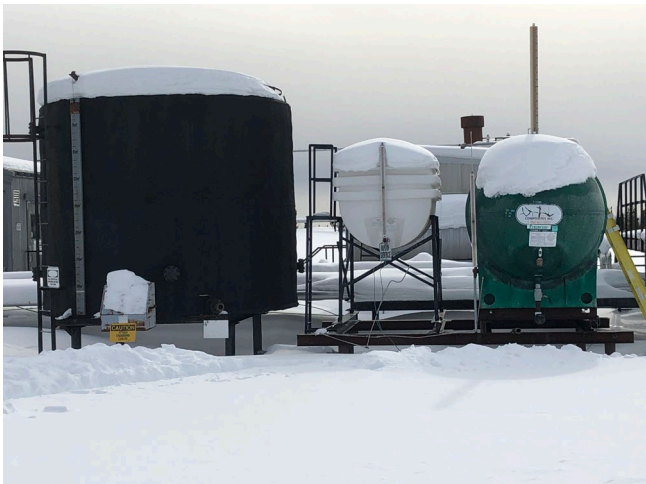
**Photo # 7:** H-03 Battery methanol tank signed "Out of Service".

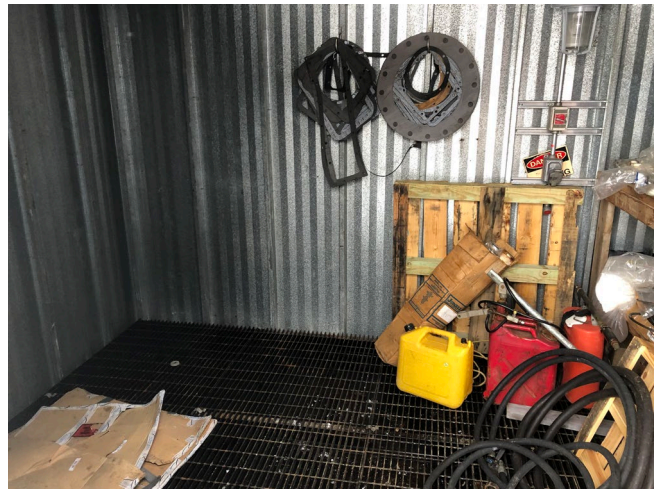
- Bulk refueling tank for generator was leaking at the fuel filter into secondary containment. Filter replaced, valves before the filter shut off, contaminated snow removed to proper containment for disposal at an approved facility;
- Generator still awaiting parts for repairs – no cathodic protection in operation at the time of inspection;
- Methanol tank, identified in the February 2019 Operations Summary Inspection Report, was empty and signed “Out of Service” (See Photo #7) and
- Drums at the barrel dock identified in the February 2019 Operations Summary Inspection Report. All drums had been removed. (See Photo # 8).

**Photo # 8:** H-03 Battery barrel dock. All drums removed..
