## WELL INSPECTION REPORT

Well Name:	Paramount et al Liard 2K-29		
Coordinates: <i>(verify onsite)</i>	Lat:	60 ° 28 ' 40 "	Long: 123 ° 35 ' 5 "
	Datum:	NAD83	
Well Operator:	Paramount Resources Ltd.	Status:	Suspended
Current Inspection Date:	20-Aug-2021	WID:	11980
Previous Inspection Date:	14-Oct-2020	Completed in H <sub>2</sub> S zone?	No; % of H <sub>2</sub> S:

**Paramount et al Laird 2K-29 WID 1980 Suspended Well Inspection Photos August 20, 2021**

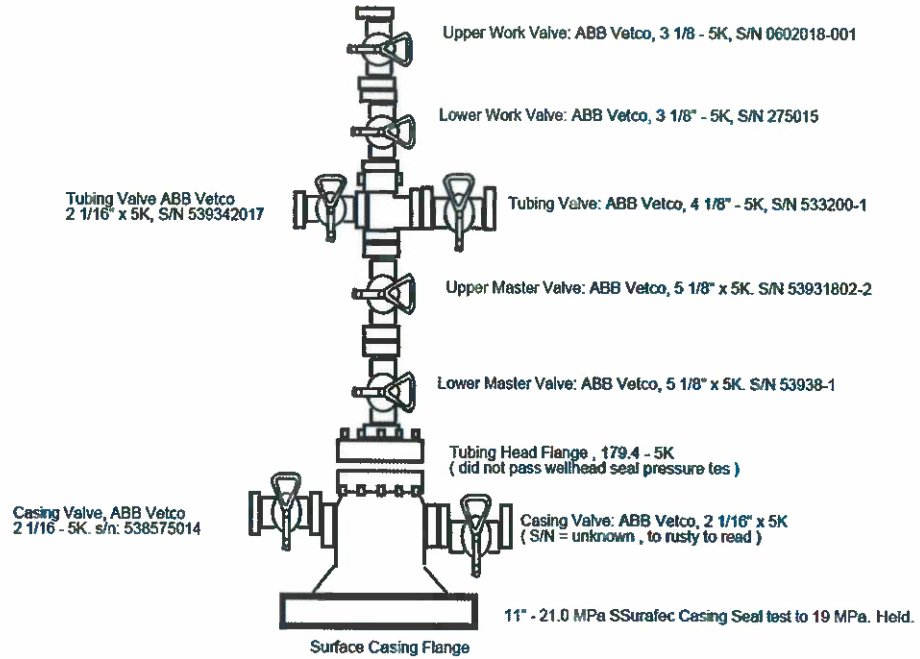
**Wellhead Schematic:**

No detection of H2S or LEL in surface or production casing.  
Pressure test 11" x 21 MPa seal against surface casing flange. Tested seal 19 MPa. held 10 minutes

Paramount et al Laird 2K-29.
